Manhole Inspection Summary

Manhole # S31E__022MH

Insp Date: **8/4/08 2:40 PM**

Location Address: **518 w fayette st**

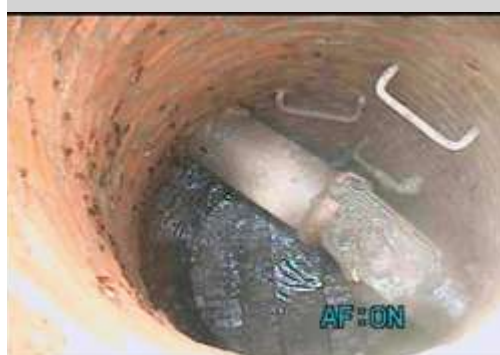
Top View

unknown pipe passing through manhole

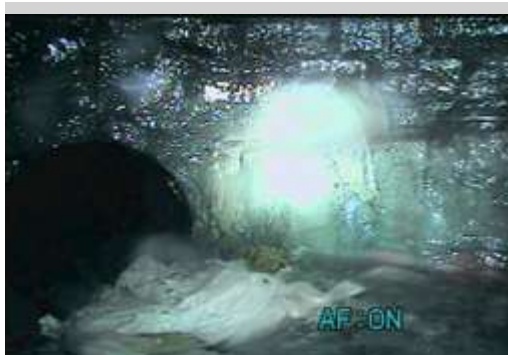
Defect 4

Condition: ☐ Sound ☐ Cracked ☐ Root Intrusion ☐ Deteriorated ☐ Leaks ☒ **Debris**

channel debris

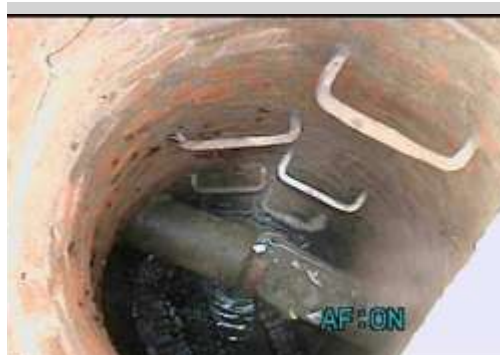
Defect 3

Count: **7** Missing: **0** ☒ **Corroded**

steps

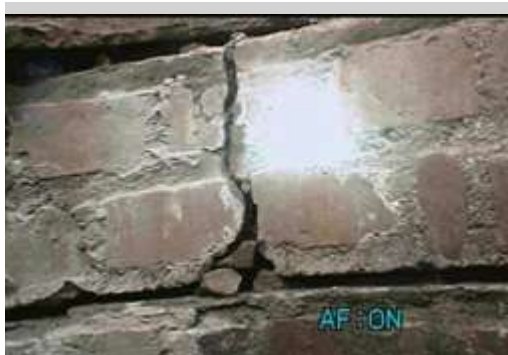
Defect 2

Condition: ☐ Sound ☒ **Cracked** ☐ Root Intrusion ☒ **Loose Brick** ☐ Deteriorated

chimney loose bricks & cracked

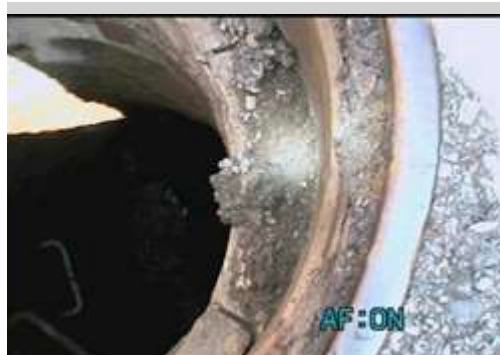
Defect 1

Offset: **3** (in.)

offset
